**Flood Control Project Maintenance
Levee Inspections**
LMA District Cover Sheet
Spring 2009 Levee Inspection Results

Merced County Stream Group

Levee Inspection Report By Mile - Spring 2009

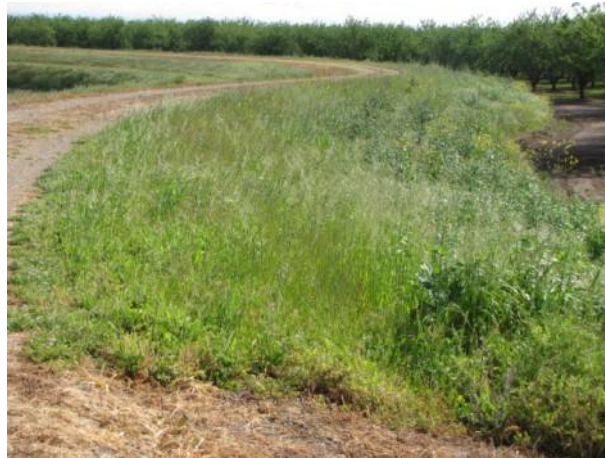
Levee Mile Report Line	1
Start Levee Mile	0.08
End Levee Mile	0.56
Location	Land Side
Category	Earthen Levee
Item	Vegetation
looking up stream of Black Rascal Creek Levee mile 0.56 to 0.08 from L/S Slope.

LMR Line	Levee Mile		Category	Item	Location *	Rating **	Action/Comment	GPS Latitude/Longitude		Photo	Issue
	Start	End						Start	End		
1	0.08	0.56	Earthen Levee	Vegetation	LS	M	Control annual grass and weeds on the levee slopes and easements.	37.336920 ° -120.387870 °	37.333390 ° -120.393850 °	Y	12
2	0.70	0.97	Earthen Levee	Animal Control	LS	M	Exterminate rodents and backfill and compact or grout burrows.	37.331107 ° -120.394673 °	37.327500 ° -120.396098 °		8
3	1.68	1.88	Earthen Levee	Vegetation	CR	M	Control annual grass and weeds on the levee slopes and easements.	37.317630 ° -120.395750 °	37.374750 ° -120.395330 °	Y	11
4	1.68	1.88	Earthen Levee	Vegetation	WS	M	Control annual grass and weeds on the levee slopes and easements.	37.317630 ° -120.395750 °	37.374750 ° -120.395330 °		10
5	1.68	1.88	Earthen Levee	Vegetation	LS	M	Control annual grass and weeds on the levee slopes and easements.	37.317630 ° -120.395750 °	37.374750 ° -120.395330 °		9

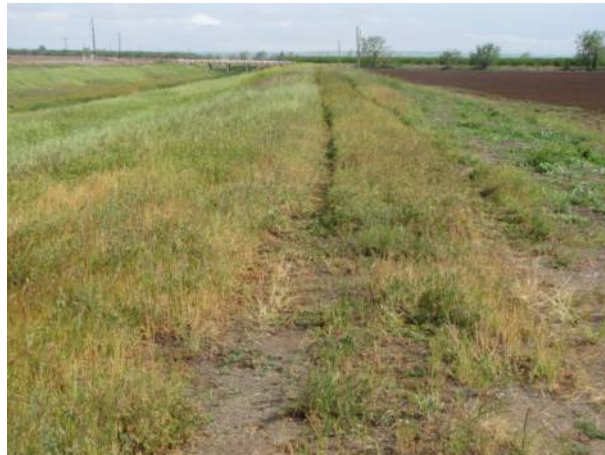
Levee Mile Report Line	3
Start Levee Mile	1.68
End Levee Mile	1.88
Location	Crown
Category	Earthen Levee
Item	Vegetation
Looking up stream Black Rascal Creek Growth on crown roadway and both slopes up to Olive Road Crossing.
